MILL INSPECTION TEMPLATE:

SAG & BALL MILLS

Site / Plant Name:	Storage places in Le Havre (France) : Amster & Roll Manutention
Country:	France
Date:	14-16 March 2022
Mill Size:	SAG 9,75m dia. x 5m (EGL), 2 x 7000kW Ball 6.4m (21') dia. x 9.6m (EGL), 8000kW <i>Still to be confirmed</i>
Client Mill Number / Name:	/
NCP Mill Serial Number:	/
Installed Mill Power:	See above
Mill Type (Ball, SAG, AG):	One SAG mill & One Ball mill
Liner Type (Steel, Rubber, Polymet)	Steel for SAG mill and Rubber for Ball mill
Inspection Time Allowed:	3 days
Average Ambient Temperature:	10° C
NCP Inspector:	Emmanuel CHEVALIER
NCPI Reference Number:	SER22.502
Last Mill Inspection:	2 years ago, by Outotec
Next Mill Inspection:	At project go-ahead, prior to shipping the goods to site or refurbishment place(s)

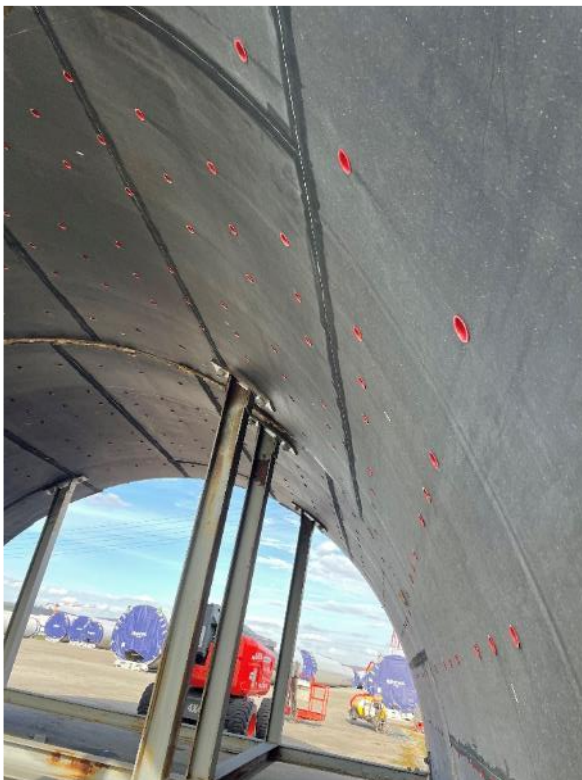
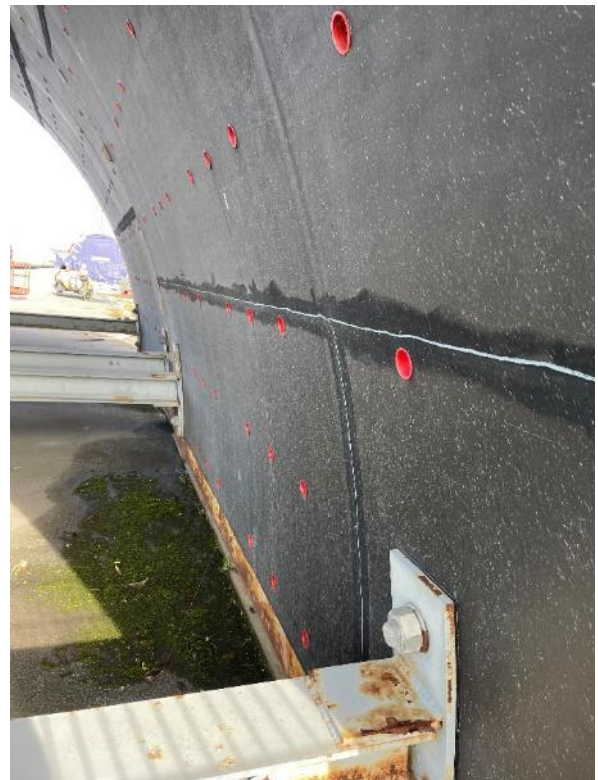
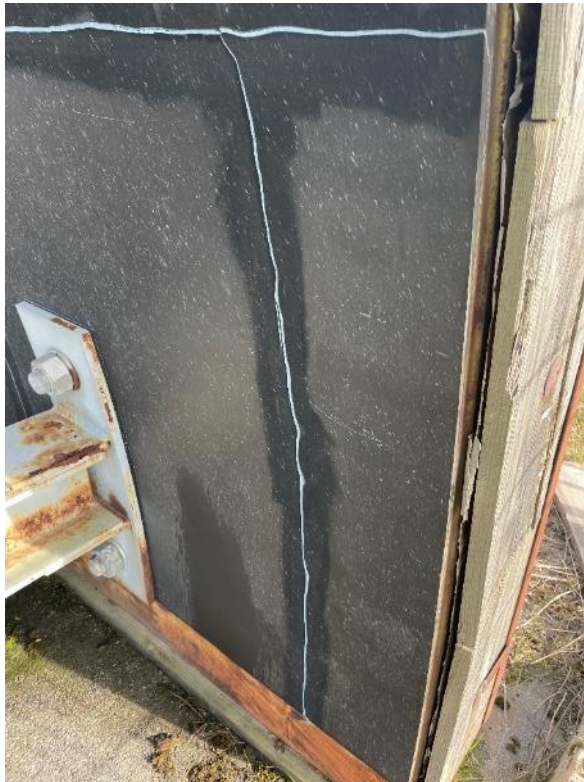
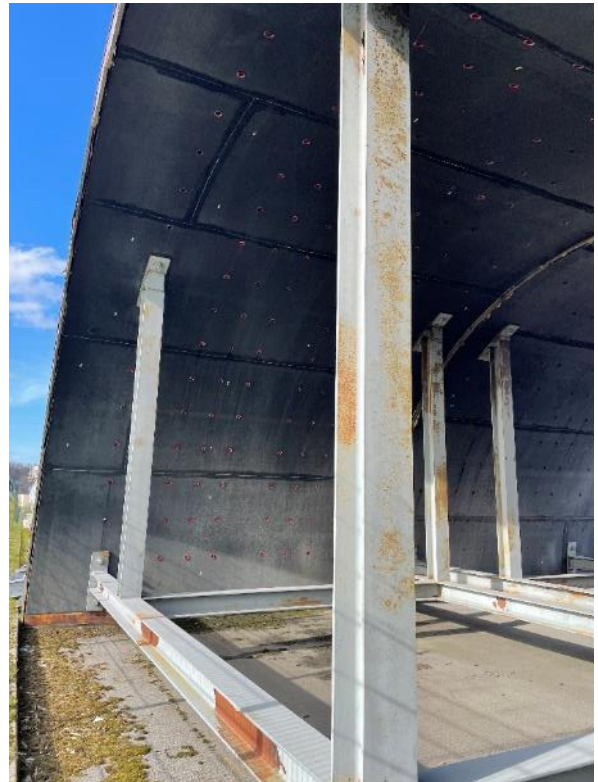
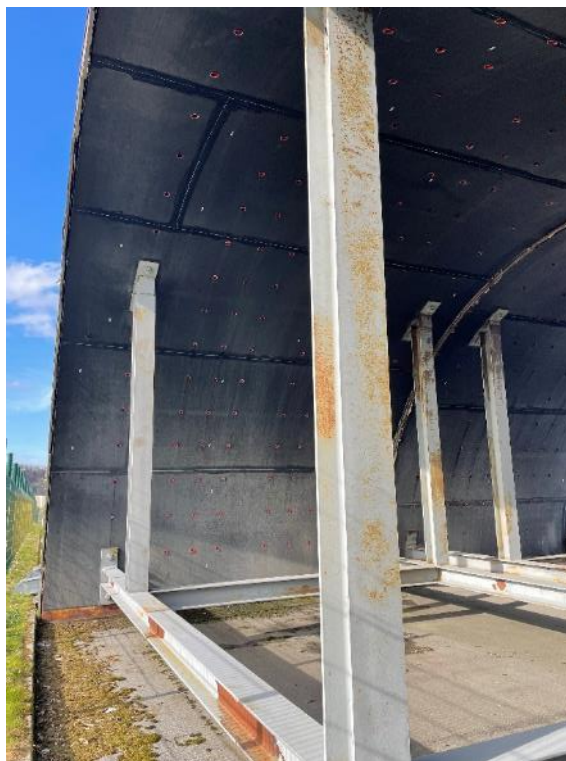
Visual inspection (2 cans at 180°): Stored outside at Roll Manutention.

The shell looks in good conditions. Most of flange wooden protection is still in place.

Nota: M:O is recommending shipping the SAG mill shell to site and clean it before installation.

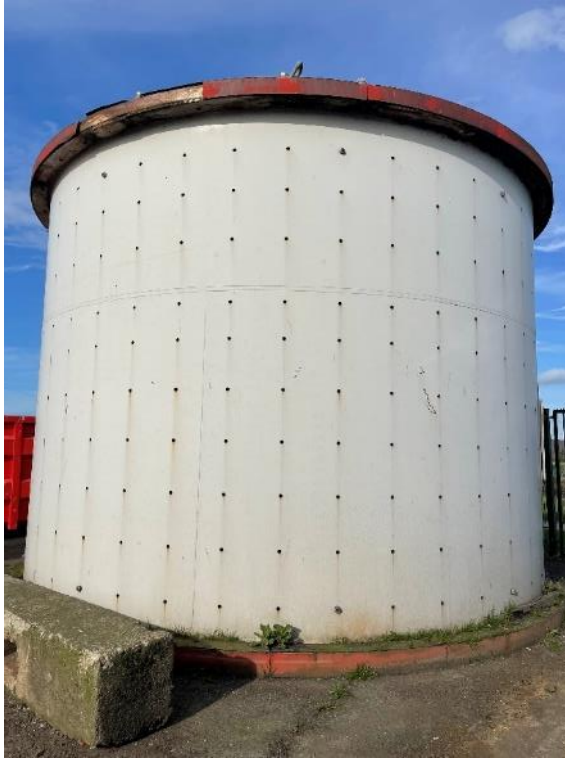
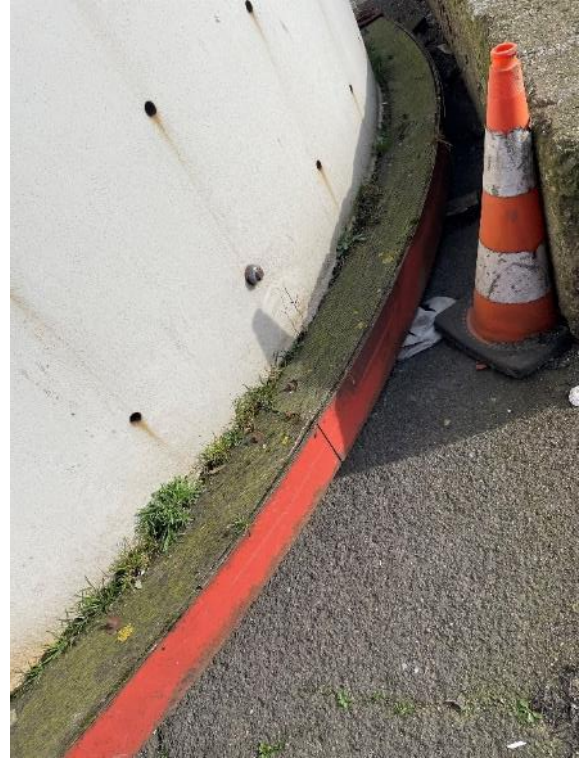
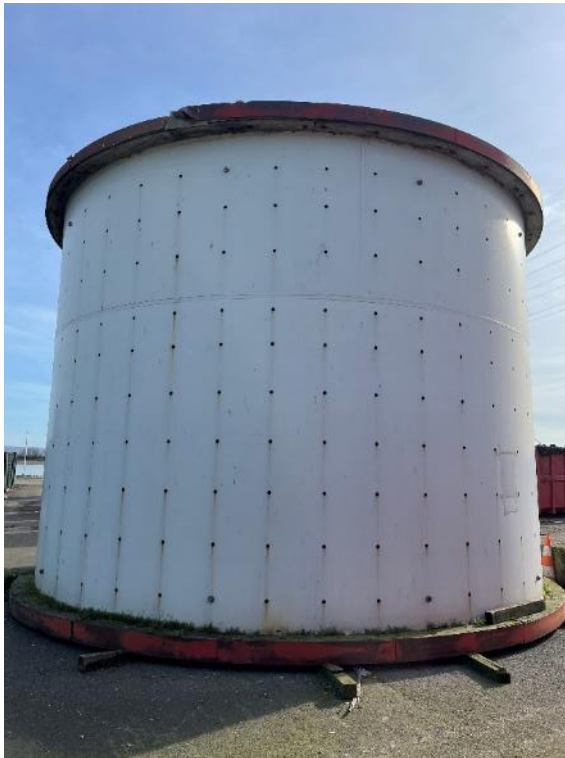
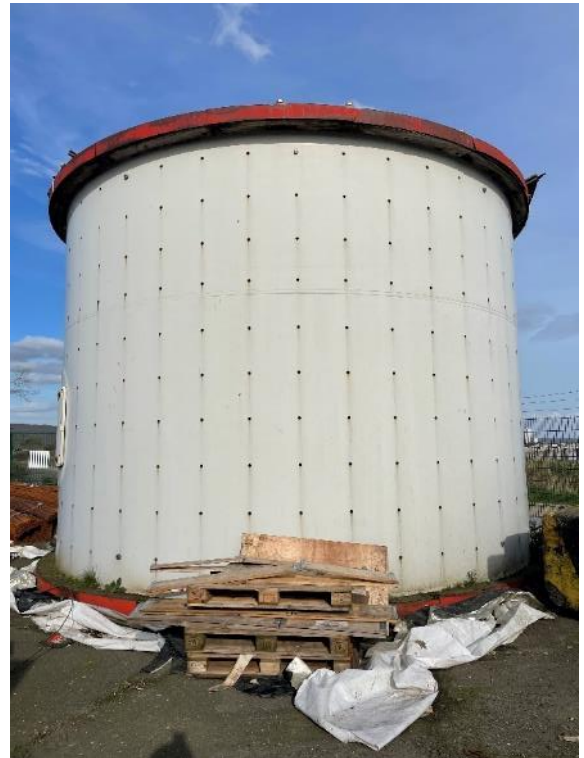
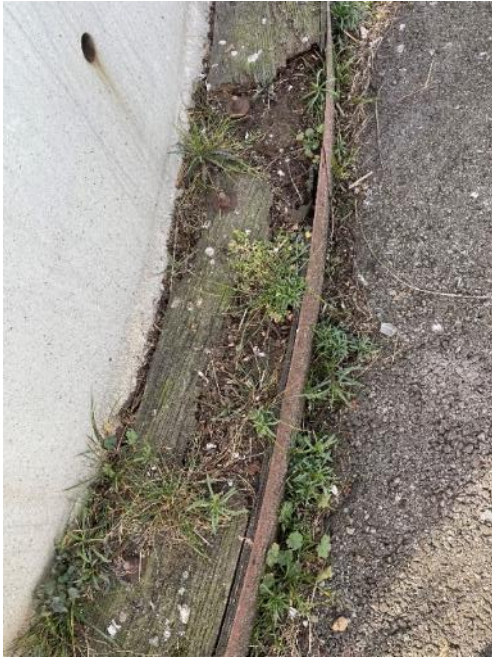
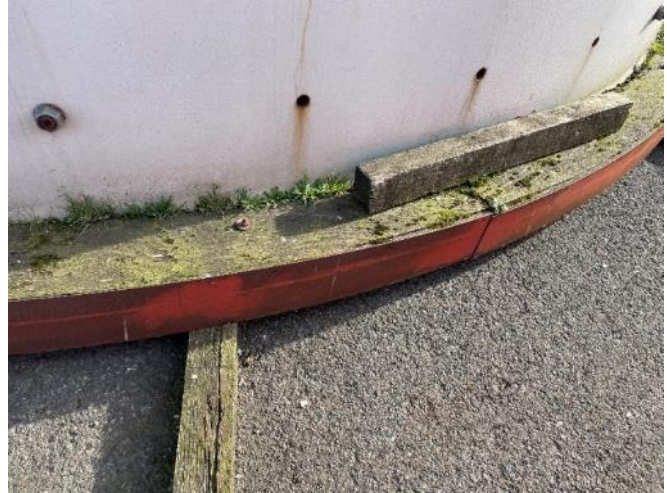
Visual inspection (2 cans at 360°): Stored outside at Roll Manutention.

The shell looks in good conditions. Most of flange wooden protection is still in place.

Nota: M:O is recommending shipping the Ball mill shell to site and clean it before installation.

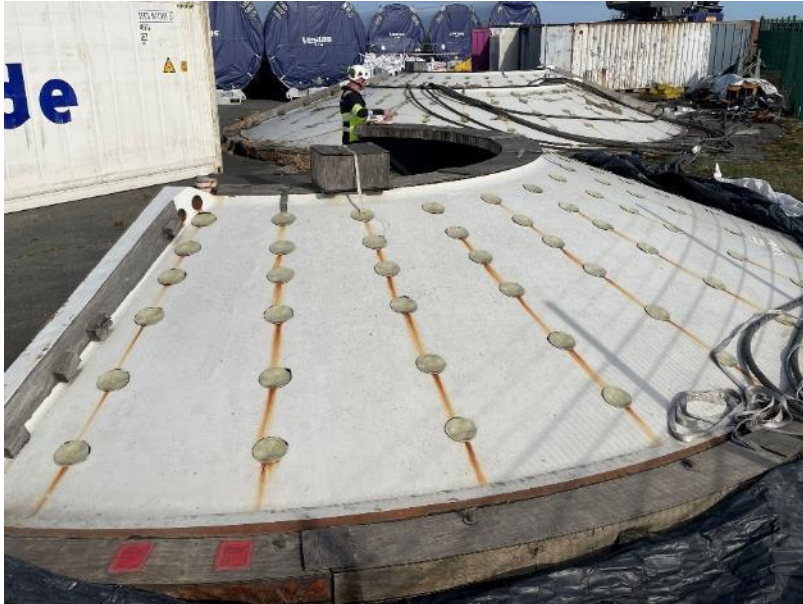
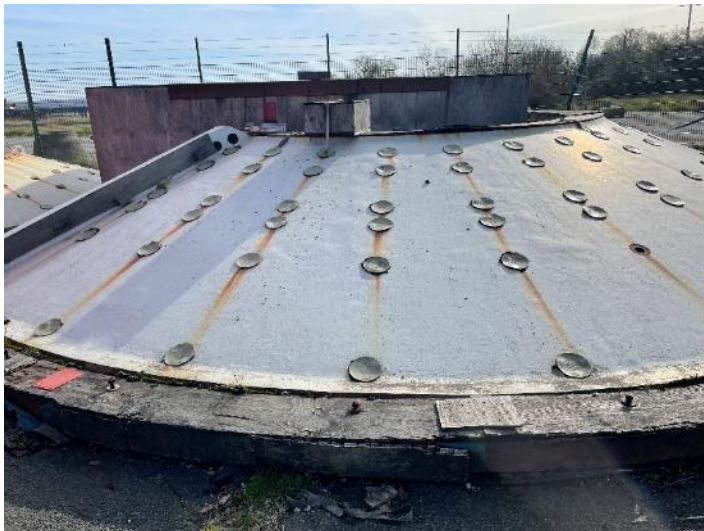
Visual inspection (4 segments at 180°): Stored outside at Roll Manutention.

Most of the wooden packing is still in place on the inner flange on the outer flange.

The wooden crate on top of the mill heads is, according to Outotec, for lifting lugs but we did not open it.

Nota: M:O is recommending shipping the SAG mill heads to a workshop for cleaning and inspection prior to assess if any machining is required prior to shipping the head segments to site.

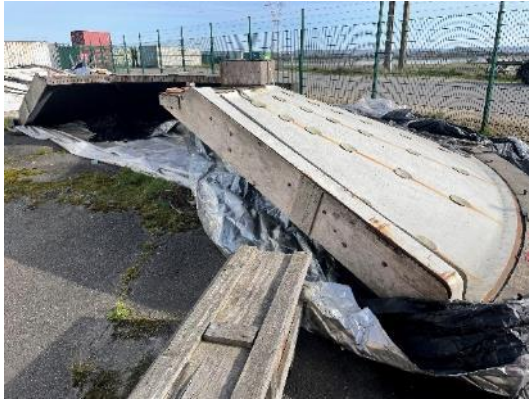
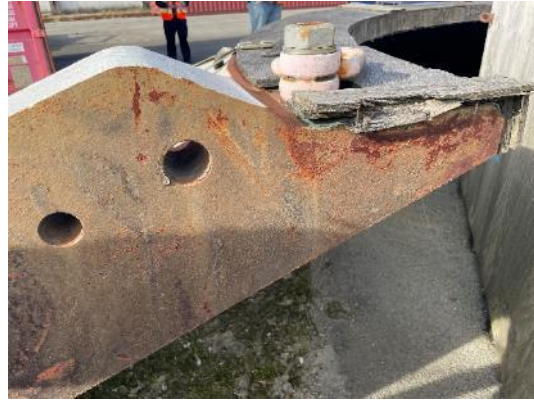
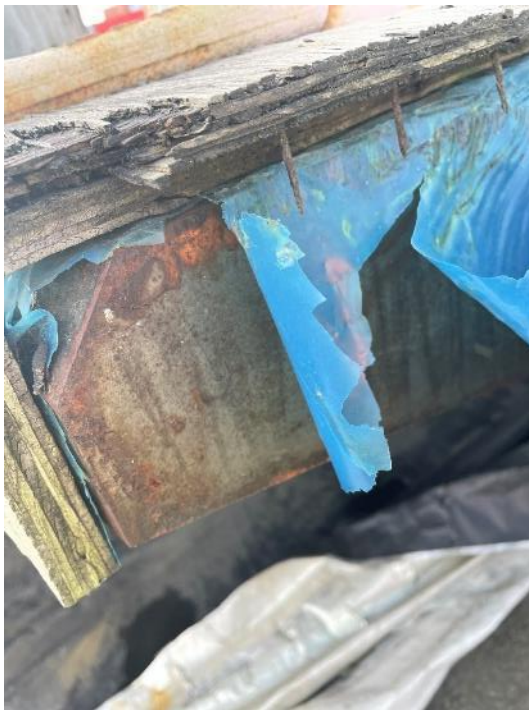
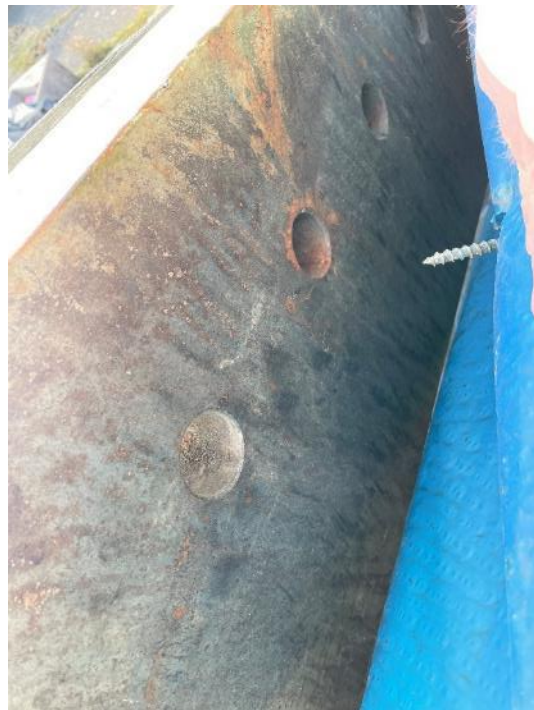
The wooden packing is broken at a few places on the bolting flange.

No indent is noted.

The rust preventive seems to still be heavily present but disappeared in a few places only, that we had access to.

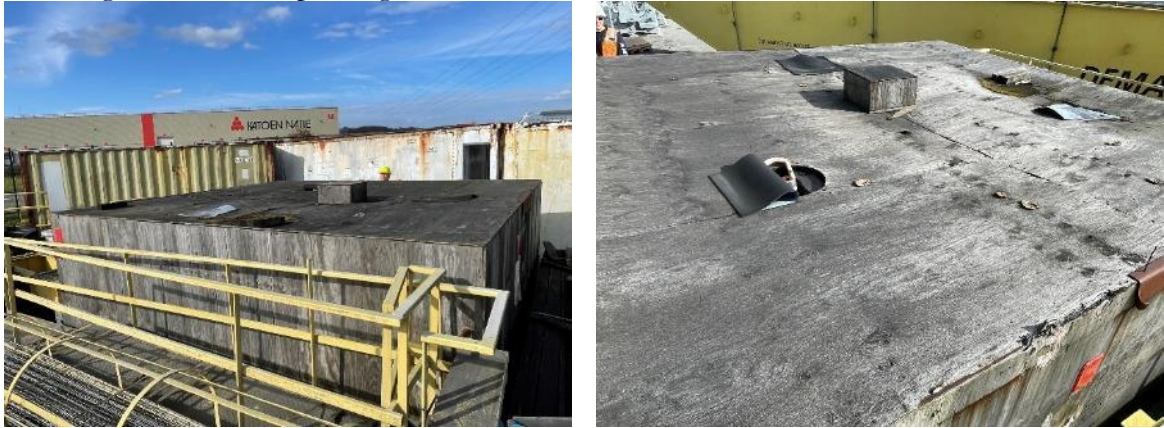
Discharge Trunnion to packing list OUT-SIE-006

Nobody could help for unpacking so we just made a opening on one side to see how it looked and the protection seems to still be OK

We can only suspect that the Discharge Trunnion could be in the same conditions.

Nota: M:O is recommending shipping the Trunnions to a workshop for cleaning, inspection prior to assess if any machining is required prior to shipping the Trunnions to site.

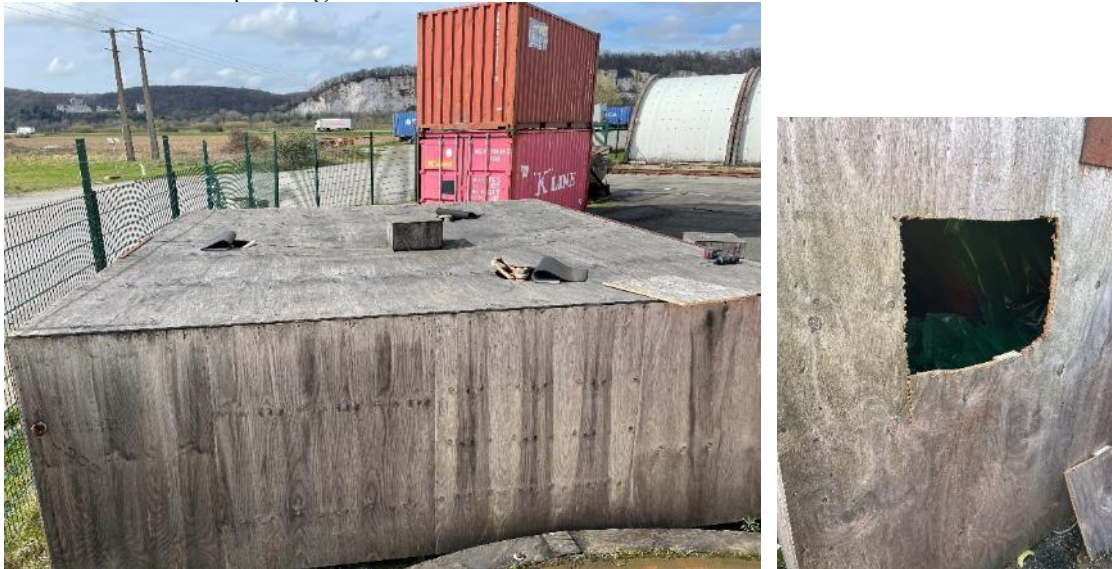
Feed Trunnion to packing list OUT-SIE-005

The rubber protection was not put back on top of the lugs so I insisted to get a larger opening so I could go inside the crate to check the protection and surface conditions.

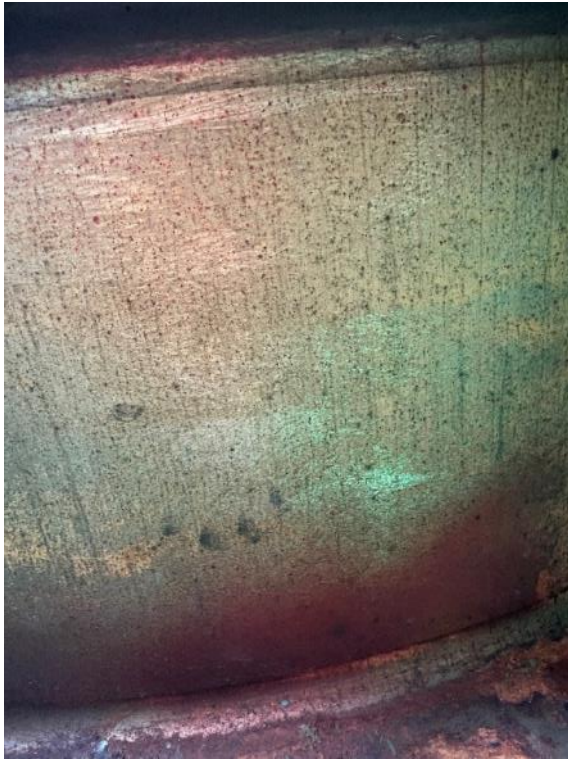
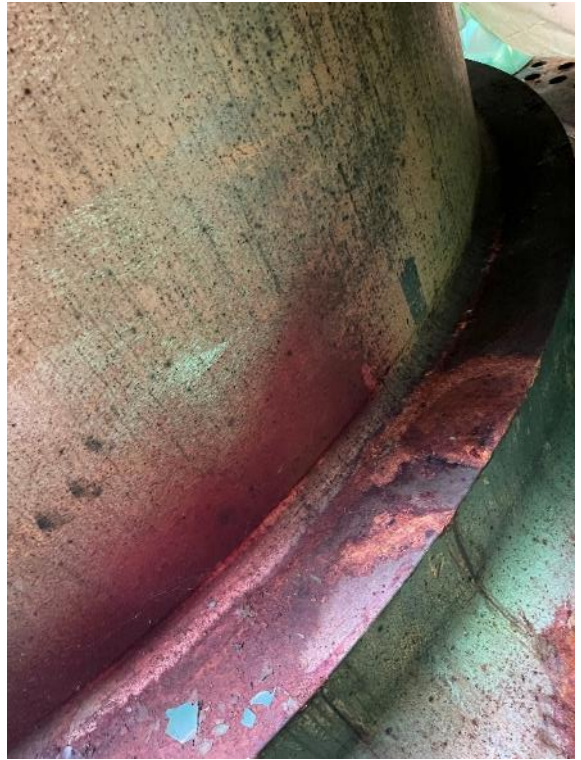
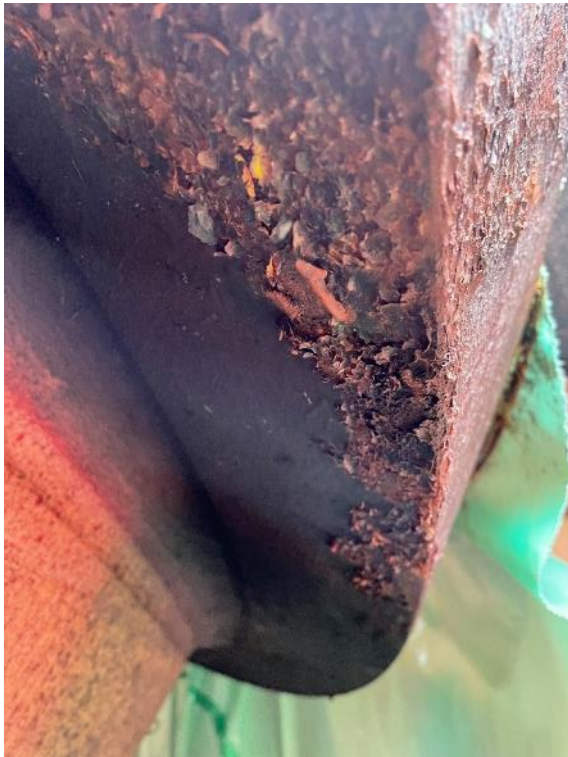
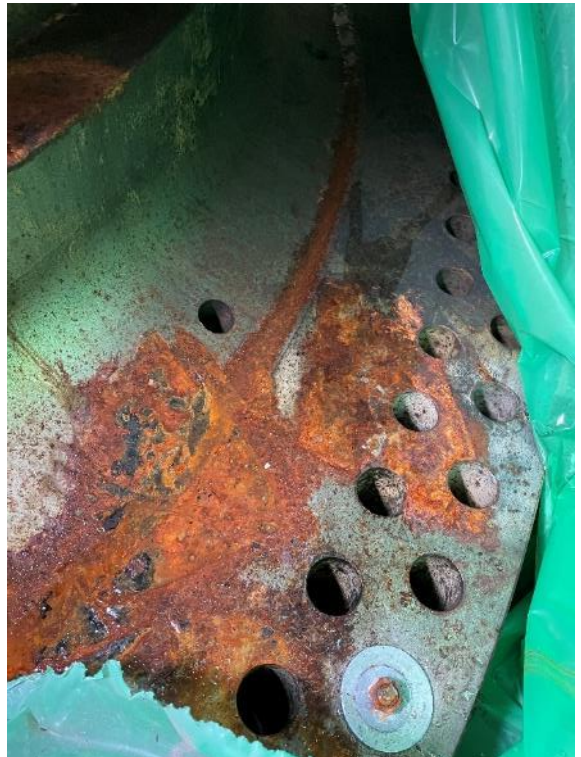
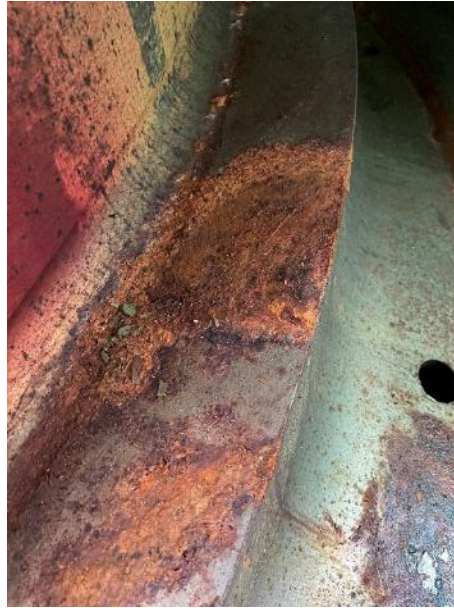
The plastic protection was full of water and the bearing surface rusted, per the pictures below.

M:O strongly believe that no machining will be required.

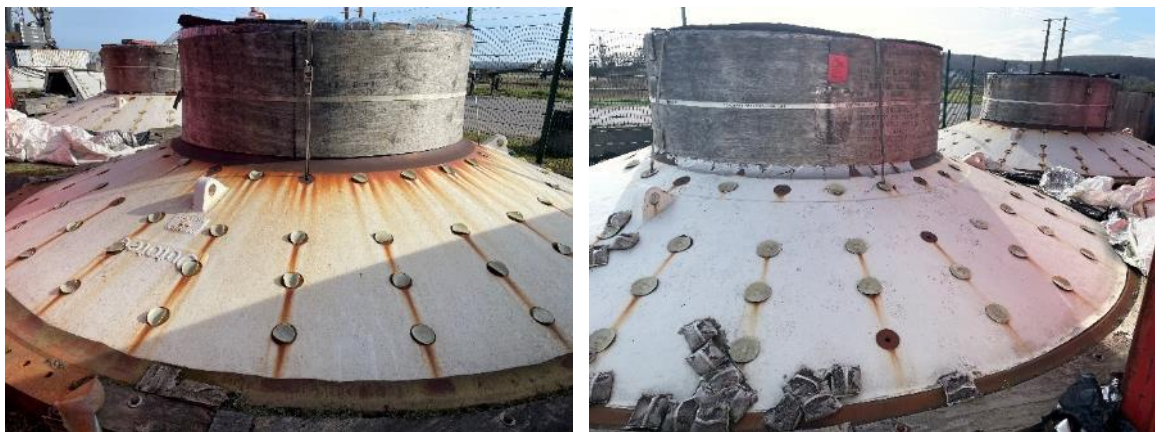
Visual inspection (2 Integral heads at 360°): Stored outside at Roll Manutention.

Nota: M:O is recommending shipping the Mill heads to a workshop for cleaning, inspection prior to assess if any machining is required prior to shipping the Mill heads to site.

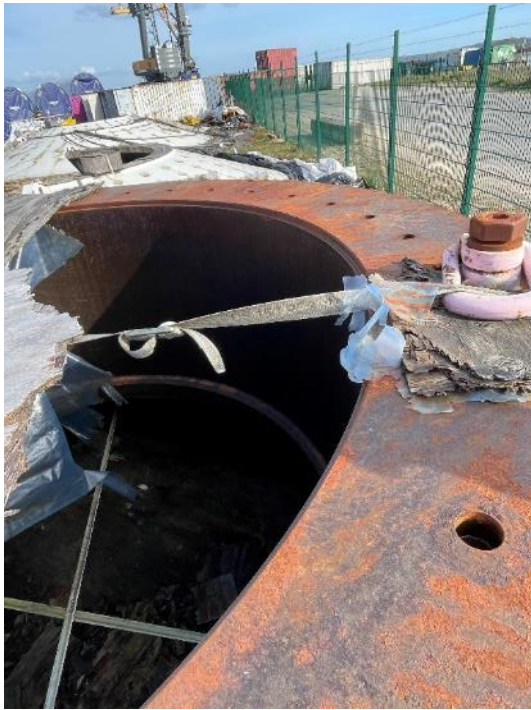
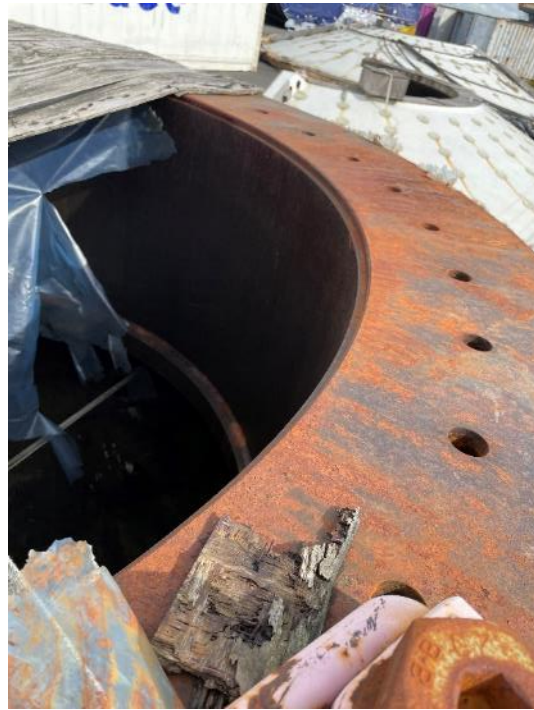
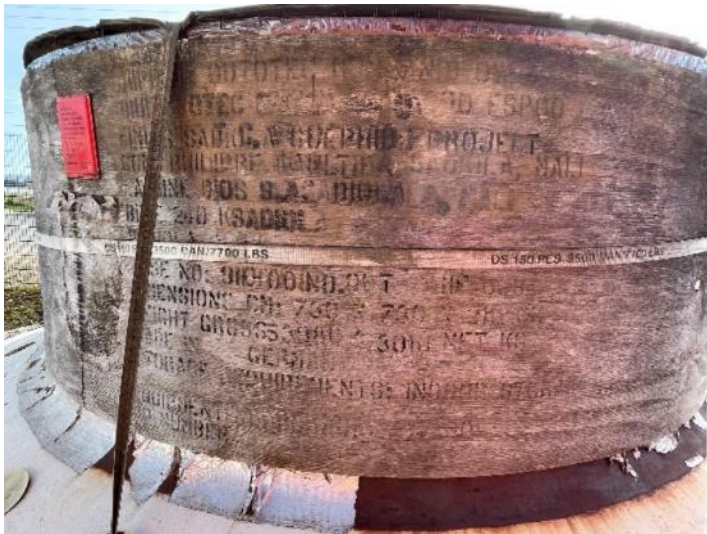
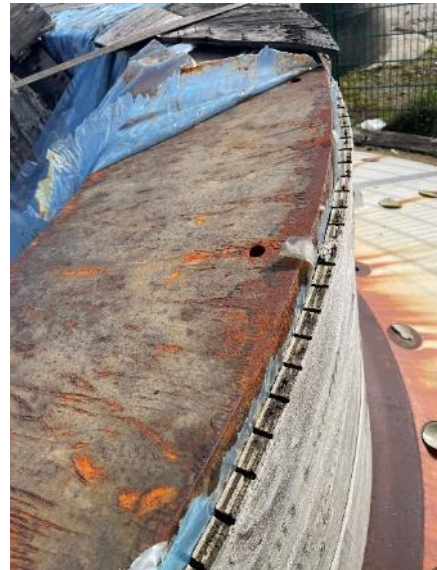
The wooden packing is still in place in many locations but well damaged in other areas where the surfaces are open to sun and rain.

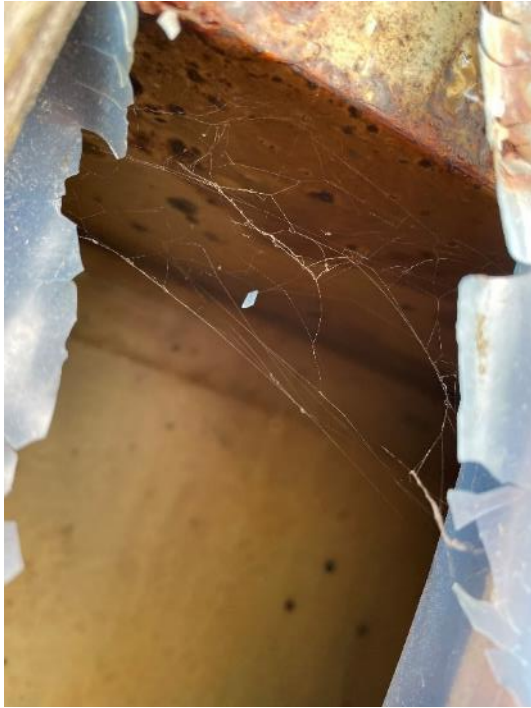
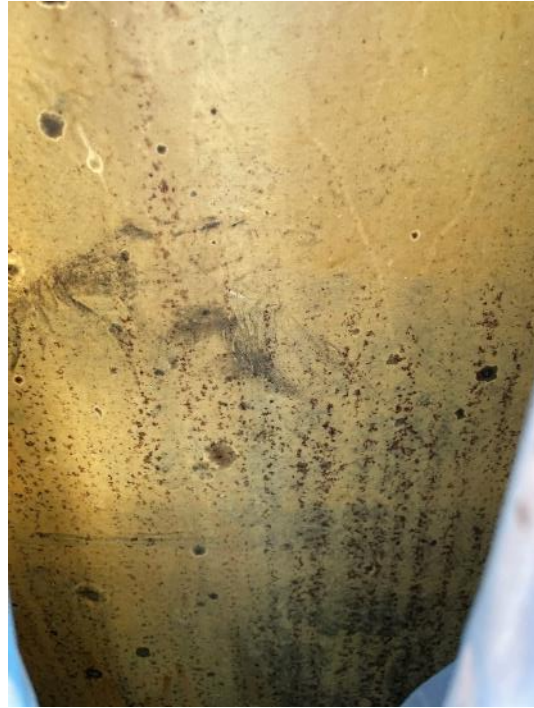
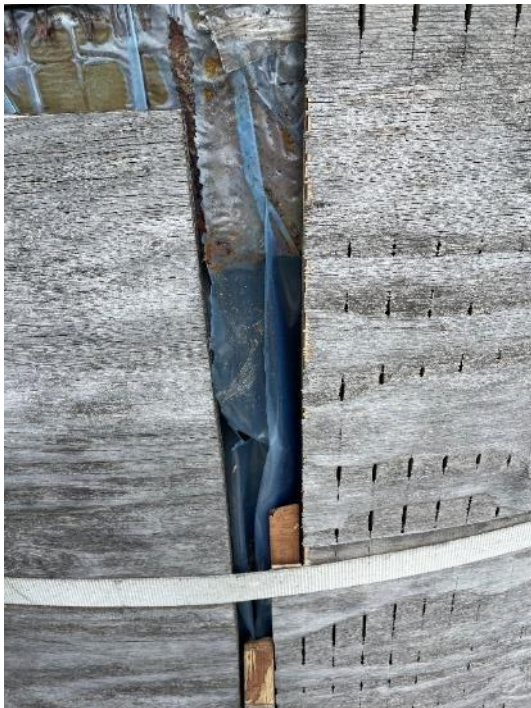
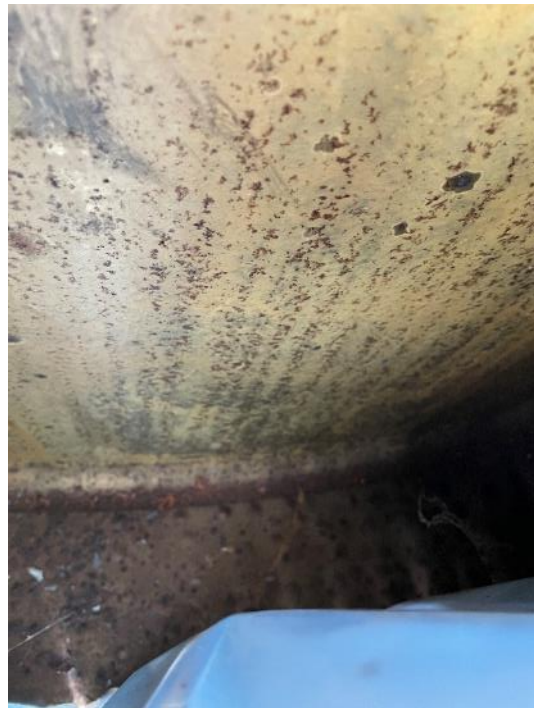
The bearing area seems to be still well protected so we did not want to break the packing to perform a more detailed inspection here.

We could however access to the bearing area through a short area with packing already damaged, per the pictures below.

It seems like the only option for M:O is to ship all heads and trunnion back to Germany for such assessment.

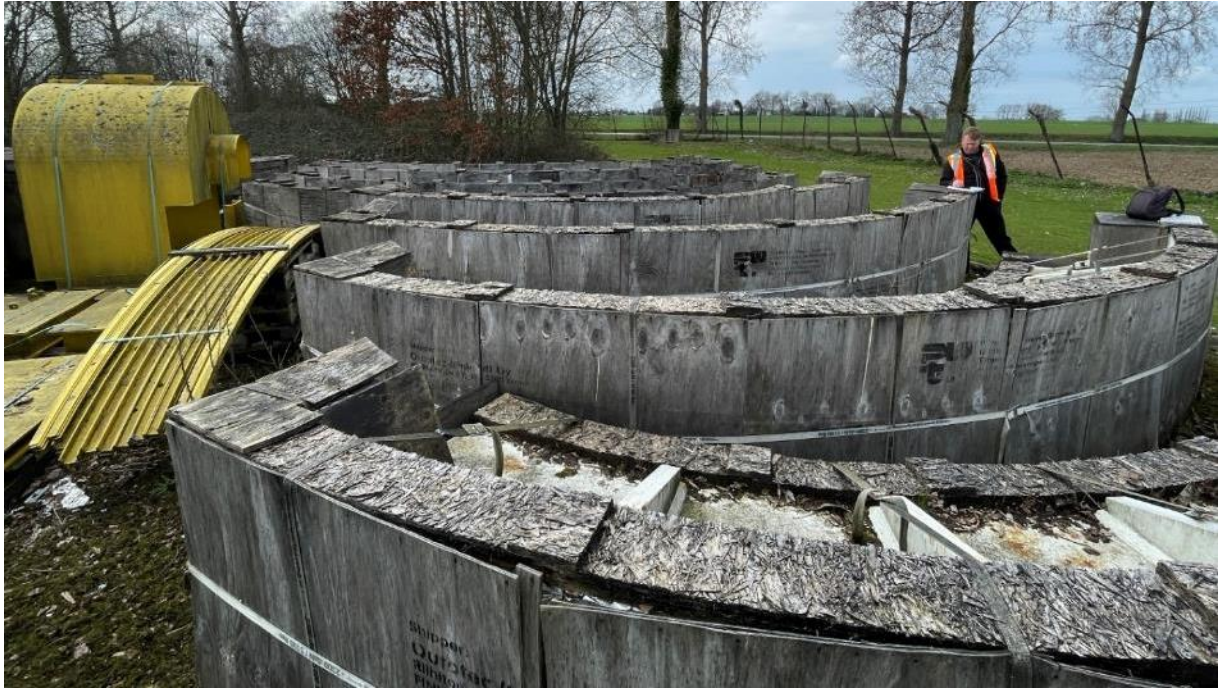
8 Gear quarters are stored outdoor at Amster

Most wooden packing is still in place but the top is well damaged. We have access to almost all assembly joints and the teeth in a few areas.

Nota: M:O is recommending shipping all gear segment to a gear manufacturer (probably VDW) for cleaning, full inspection prior to assess if any machining/cutting is required prior to shipping the gears to site.

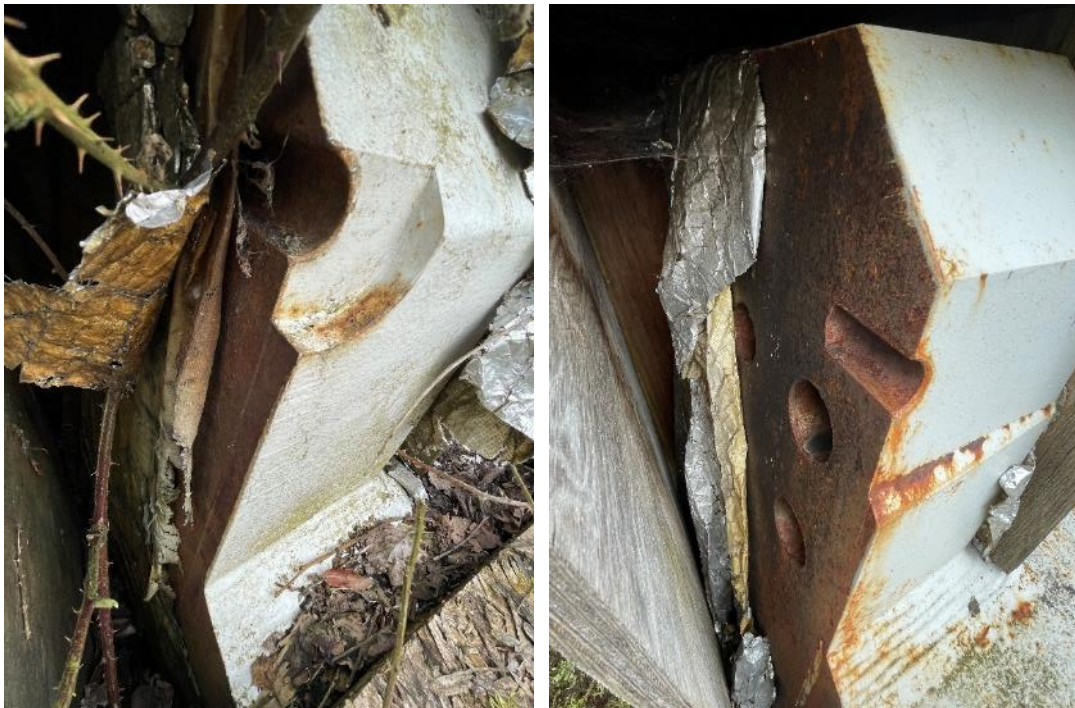
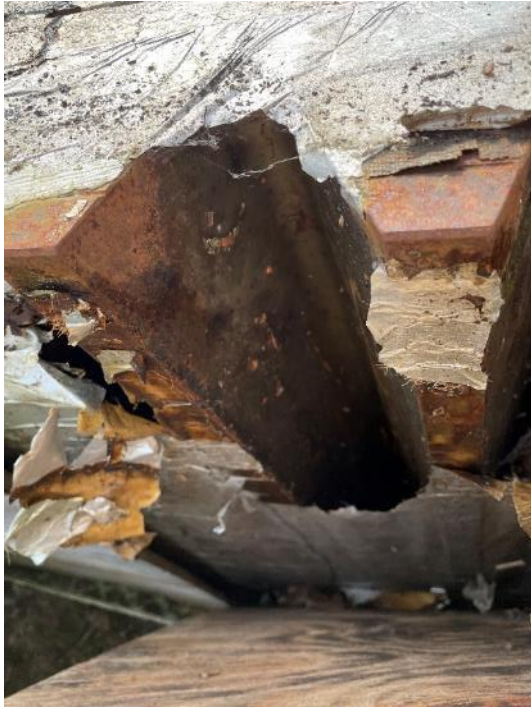
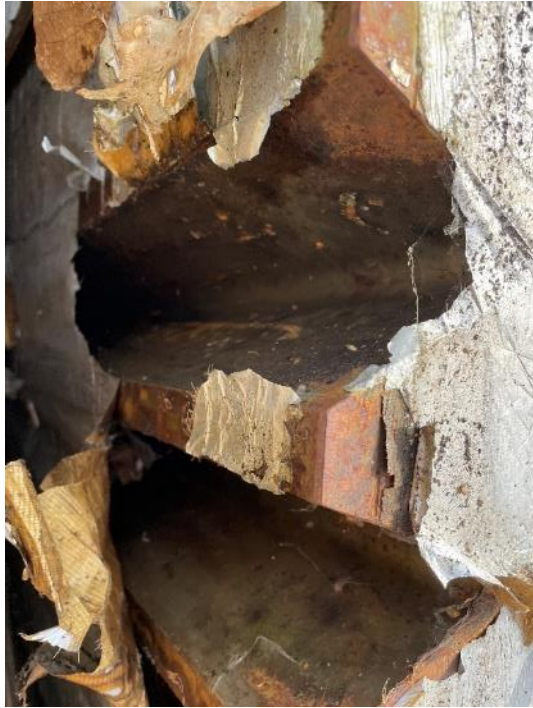
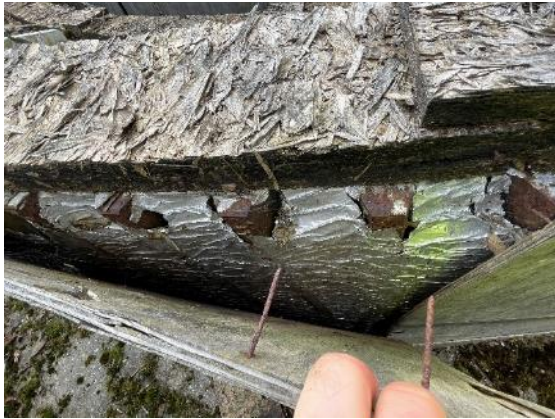
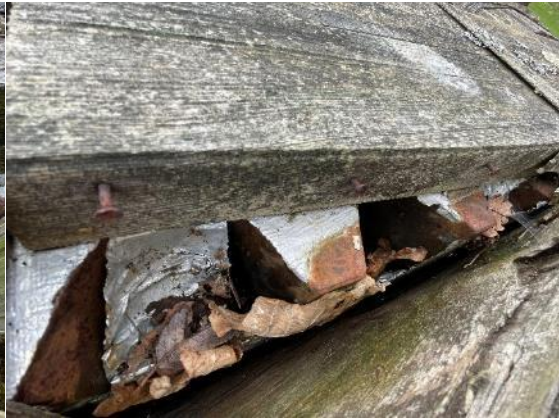
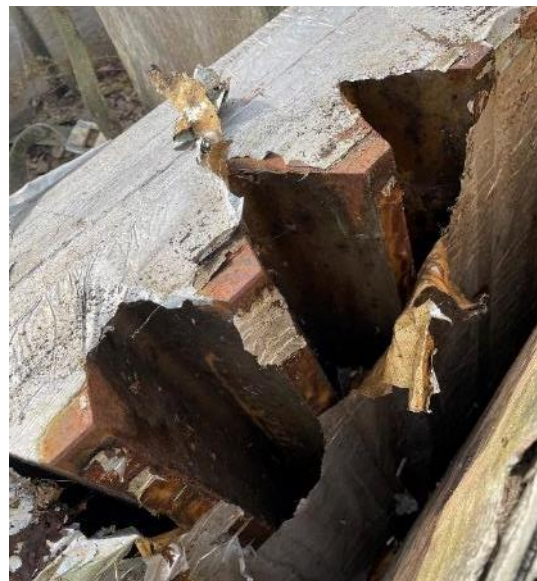
We can see a large amount of rust in the tooth area but the rust is still there.

I may not be as bad as what it looks.

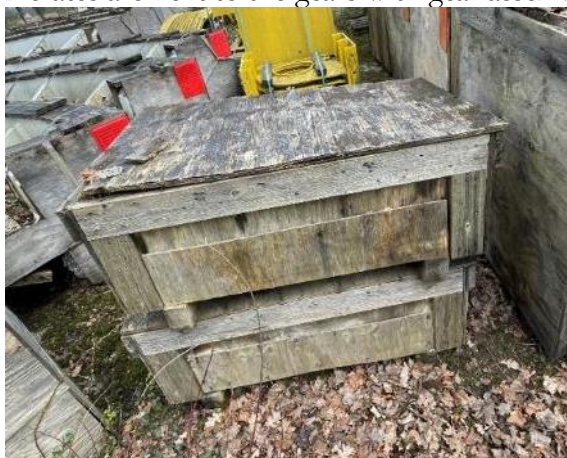
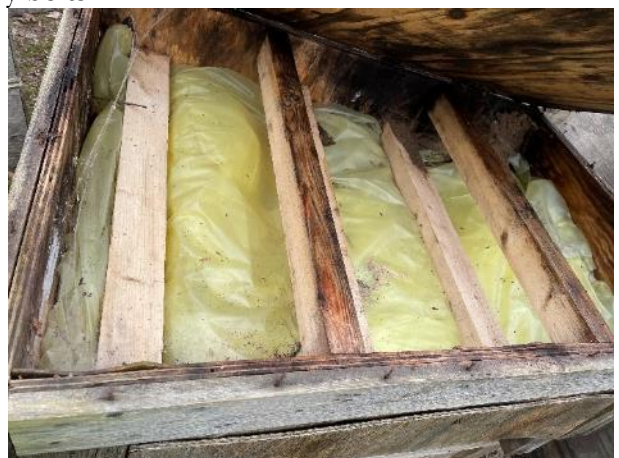
2 crates are next to the gears with gear assembly bolts:

Nota: M:O is recommending that all assembly bolts are replaced (without opening the crates!).

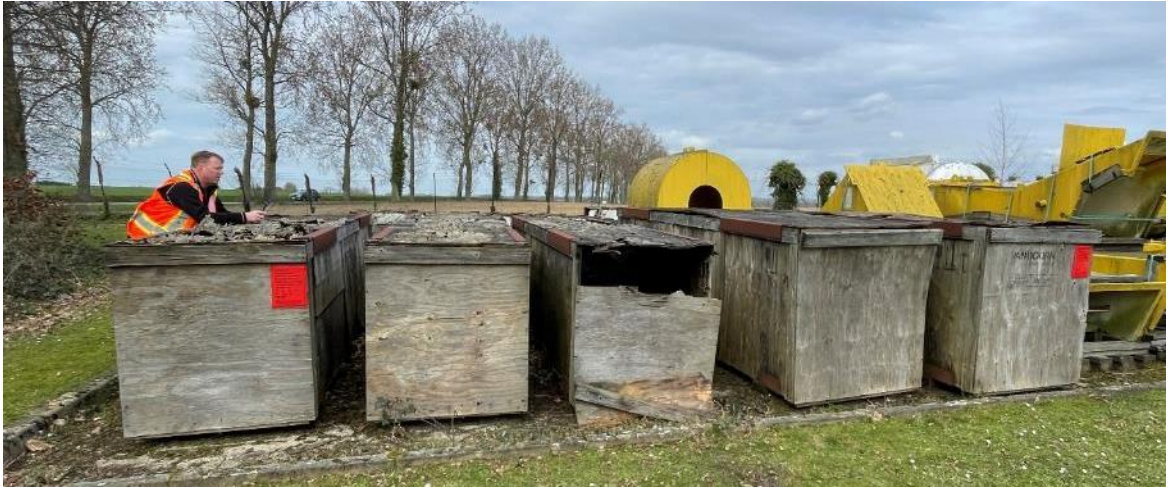
5 crates are stored outdoor at Amster, next to the gear quarters and gear guards.
Probably 2 main pinions and 1 spare for the SAG mill and 1 main pinion and 1 spare for the Ball mill.

Nota: M:O is recommending shipping all pinions to a gear manufacturer (probably VDW) for cleaning and full inspection prior to assess if any machining/cutting is required prior to shipping the pinions to site.

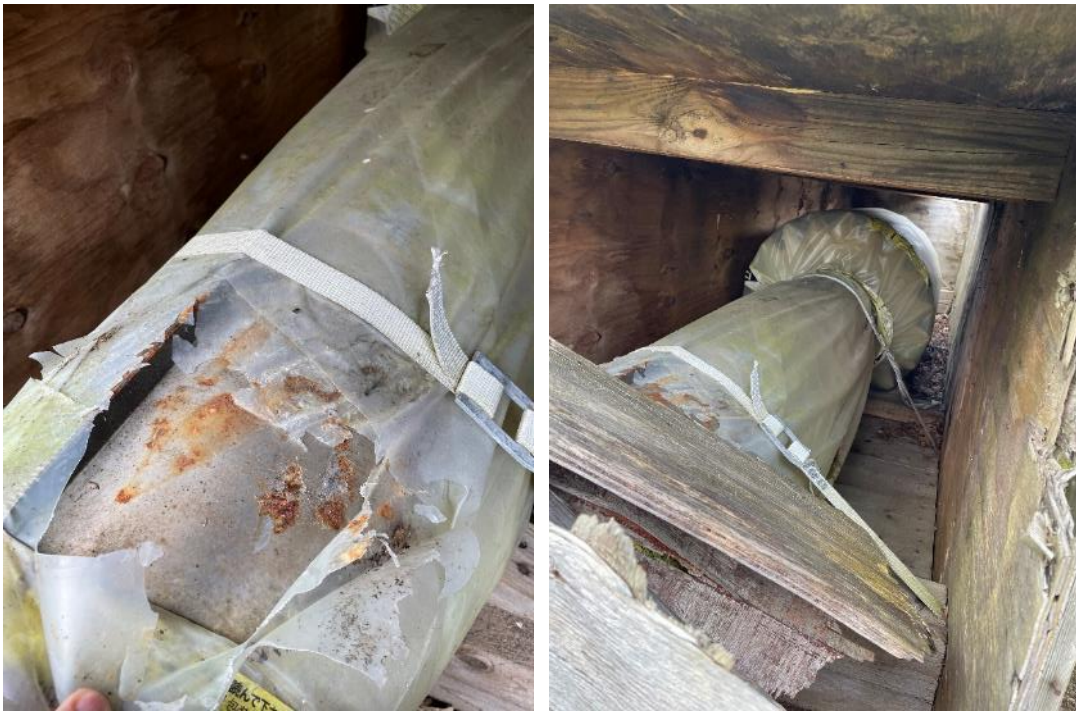
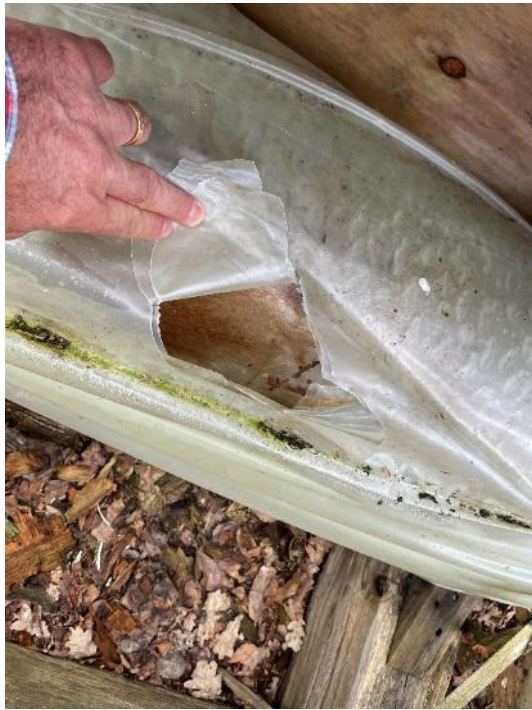
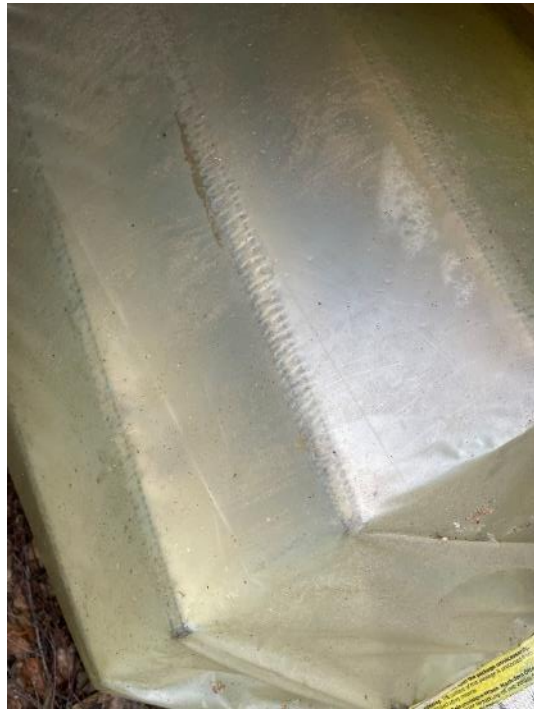
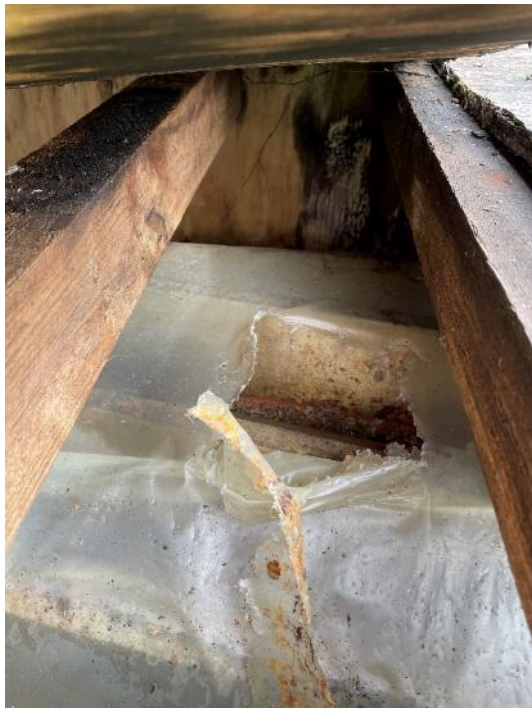
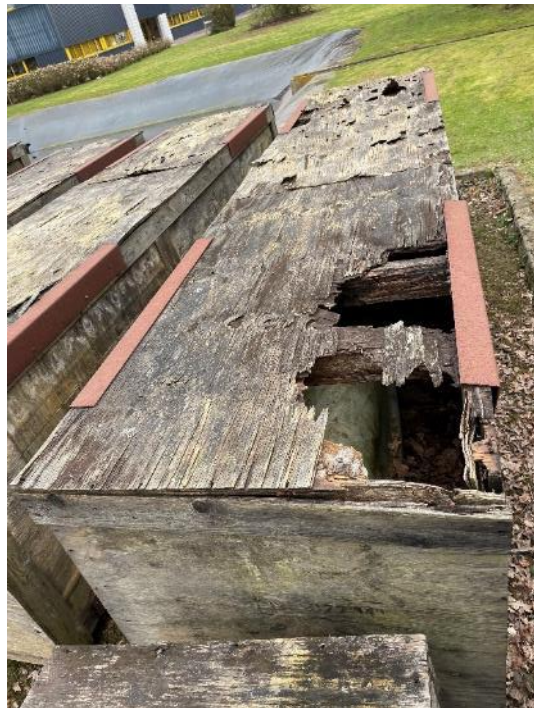
Most crates are still in acceptable conditions but one of them is damaged on the top and on the side. We could see that there is still some good plastic protection but could not assess the conditions of the bearing areas and the teeth.

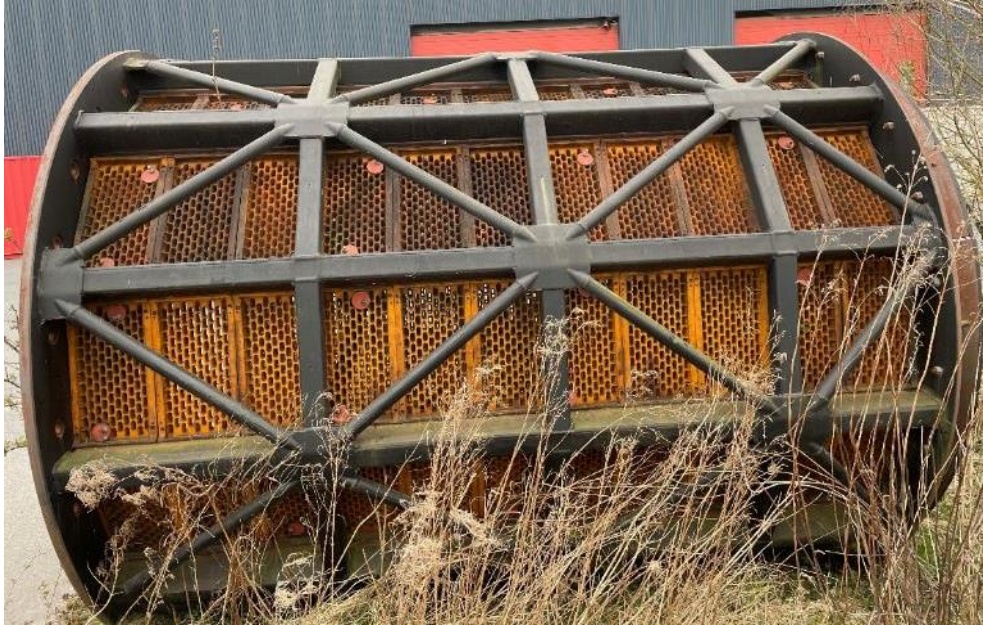
One Trommel screen is stored outside at Amster, between Building B0 and B1.

- Trommel length: 3 400 mm F/F + 200 mm at the end
- Flange details: ID 1 960 ; OD 2 770 mm ; 24 holes Ø40
- Internal distance between panels: 2 280 mm
- Panel size: 600 x 300 mm ; Aperture 14 x 32 mm
- 132 panels in total: 11 on the length and 12 on the circumference
- Size of rubber, inside the trommel: 530 x 200 x 40 mm

Nota: M:O is recommending to supply new Trommel!
