MILL INSPECTION TEMPLATE:

SAG & BALL MILLS

Site / Plant Name:	Storage places in Le Havre (France) : Amster & Roll Manutention
Country:	France
Date:	14-16 March 2022
Mill Size:	SAG 9,75m dia. x 5m (EGL), 2 x 7000kW Ball 6.4m (21') dia. x 9.6m (EGL), 8000kW <i>Still to be confirmed</i>
Client Mill Number / Name:	/
NCP Mill Serial Number:	/
Installed Mill Power:	See above
Mill Type (Ball, SAG, AG):	One SAG mill & One Ball mill
Liner Type (Steel, Rubber, Polymet)	Steel for SAG mill and Rubber for Ball mill
Inspection Time Allowed:	3 days
Average Ambient Temperature:	10° C
NCP Inspector:	Emmanuel CHEVALIER
NCPI Reference Number:	SER22.502
Last Mill Inspection:	2 years ago, by Outotec
Next Mill Inspection:	At project go-ahead, prior to shipping the goods to site or refurbishment place(s)

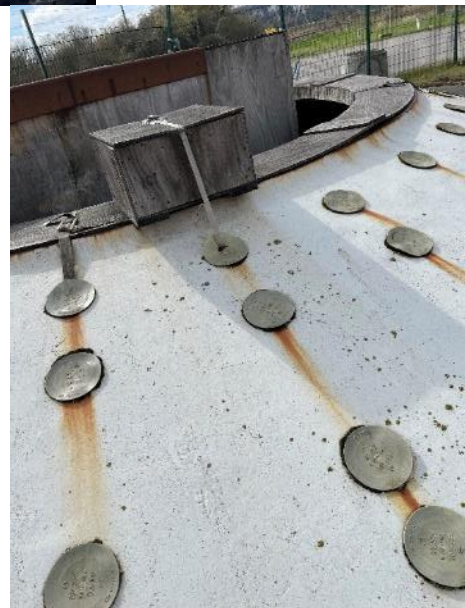
Most of the wooden packing is still in place on the inner flange on the outer flange.

The wooden crate on top of the mill heads is, according to Outotec, for lifting lugs but we did not open it.

Nota: M:O is recommending shipping the SAG mill heads to a workshop for cleaning and inspection prior to assess if any machining is required prior to shipping the head segments to site.

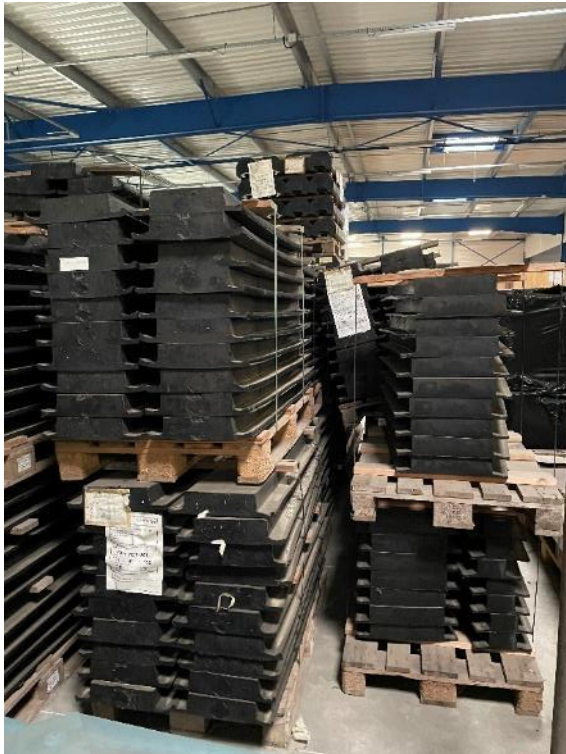
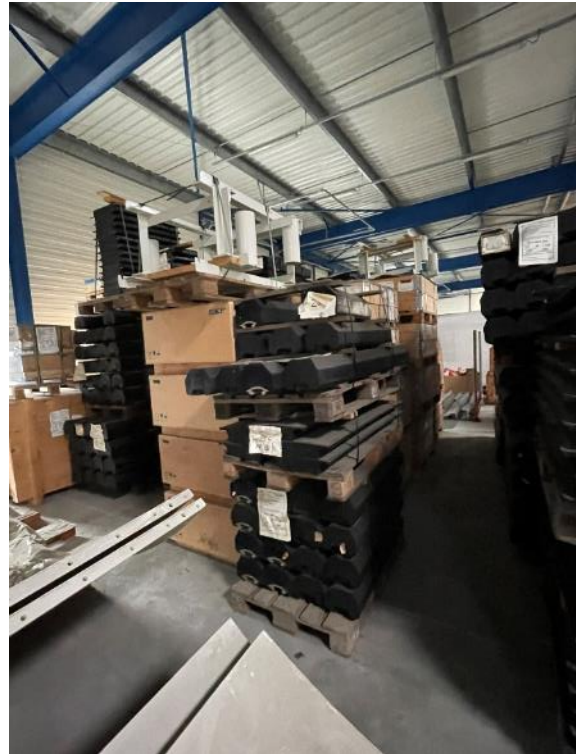
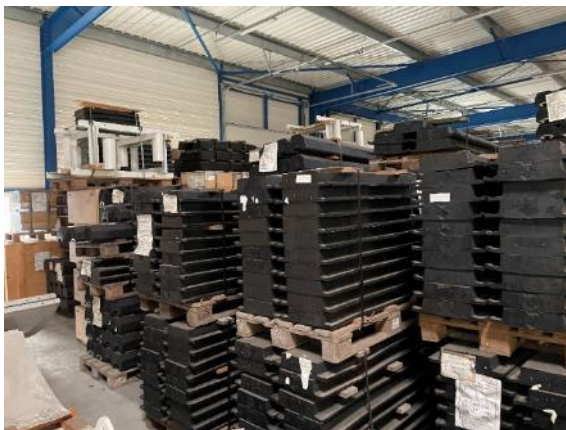
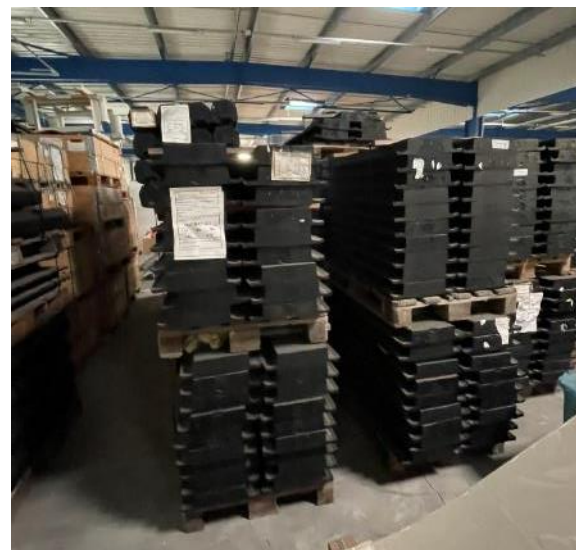
These Rubber liners are stored indoor at Amster, Building B1.

We could not count the number of liners but a lot of them could be seen in the building.

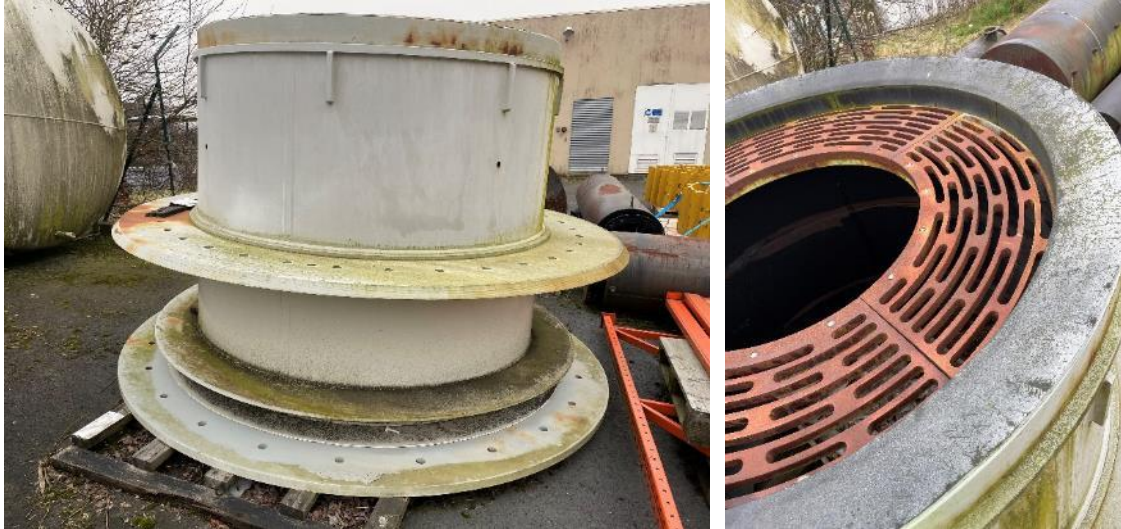
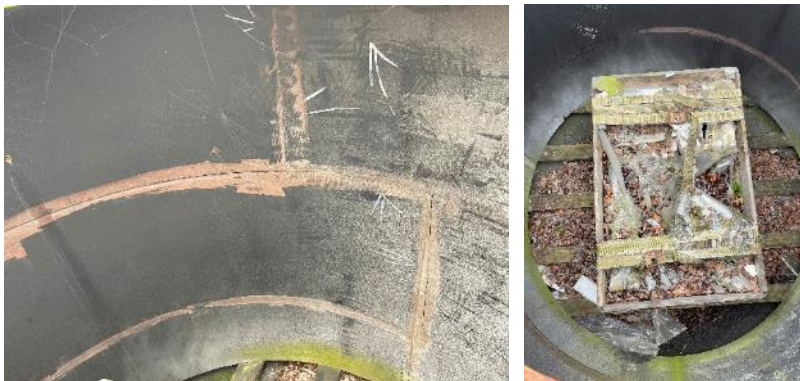
A/ Insert #1, closed to B0 Building:

Some dimensions were checked:

- OD 1 960 mm ; Total height 1 760 mm
- Bottom flange details: OD 2 760 mm ; Thickness 40 mm ; 24 holes Ø40
- Middle flange details: OD 2 760 mm ; Thickness 40 mm ; 36 holes Ø40

Seems to be fine to ship these directly to site.

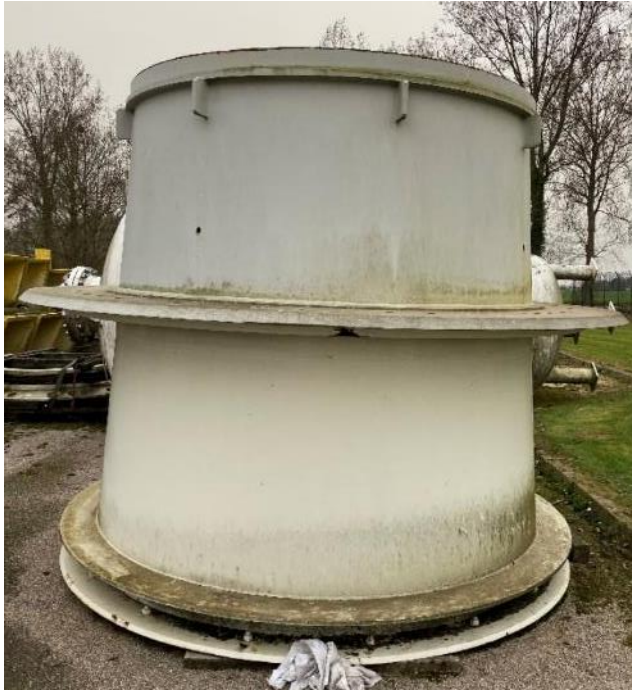
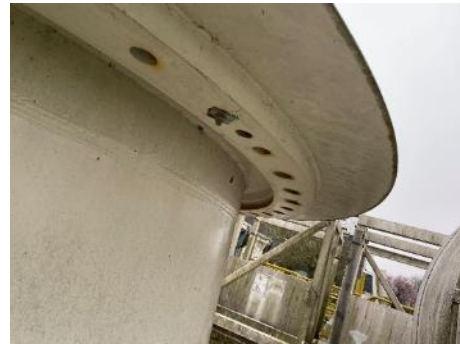
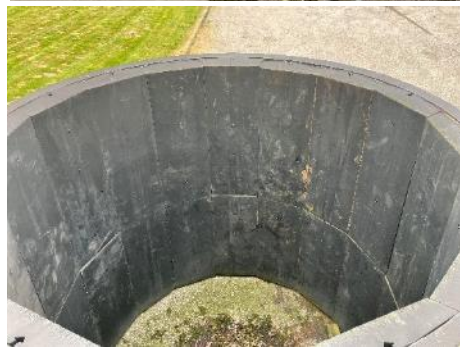
B/ Insert #2, next to the gear quarters:

Some dimensions were checked:

- OD 2 300 mm ; Total height 2 540 mm
- Bottom flange details: OD 2 660 mm ; Thickness 20 mm ; 16 holes
- Middle flange details: OD 3 280 mm ; Thickness 50 mm ; 48 holes Ø45

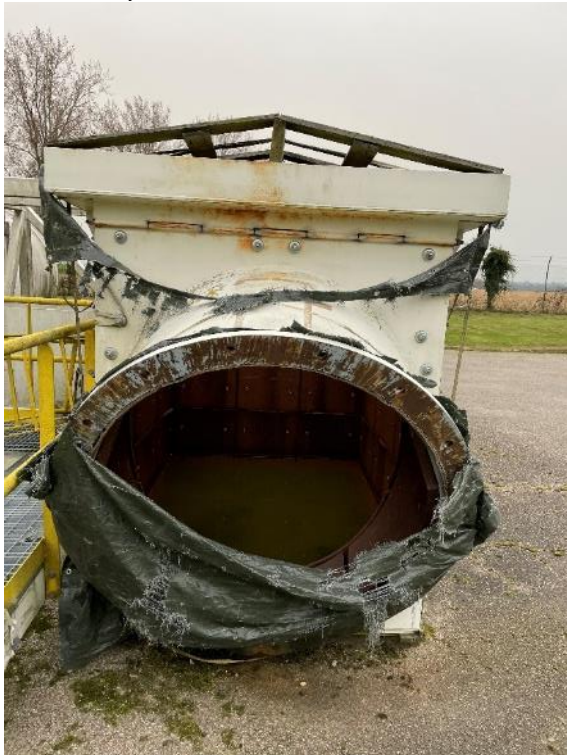
Flange OD 1500 / Flange ID 1280

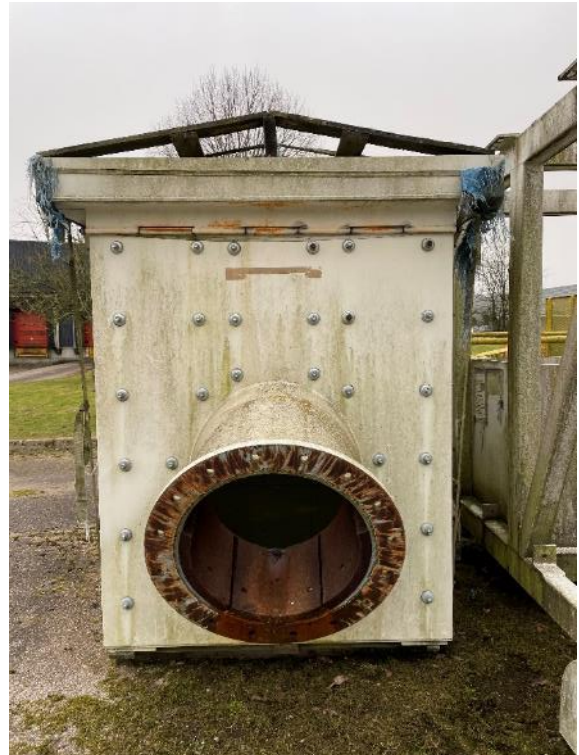
Flange OD 900 / Flange ID 700

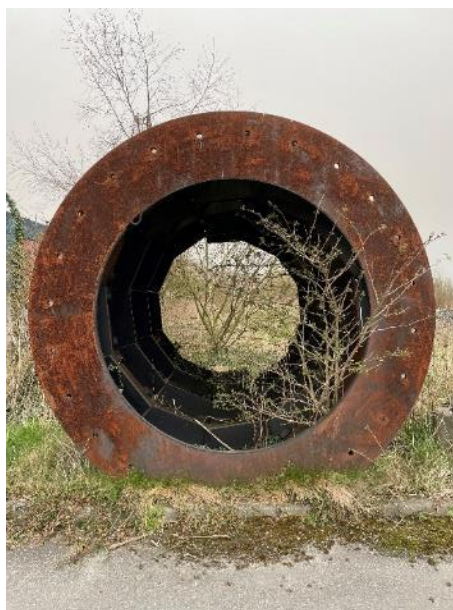
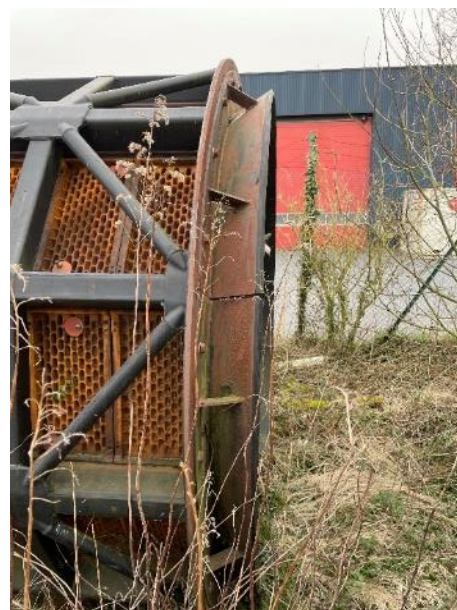
One Trommel screen is stored outside at Amster, between Building B0 and B1.

Some dimensions were taken:

- Trommel length: 3 400 mm F/F + 200 mm at the end
- Flange details: ID 1 960 ; OD 2 770 mm ; 24 holes Ø40
- Internal distance between panels: 2 280 mm
- Panel size: 600 x 300 mm ; Aperture 14 x 32 mm
- 132 panels in total: 11 on the length and 12 on the circumference
- Size of rubber, inside the trommel: 530 x 200 x 40 mm

Nota: M:O is recommending to supply new Trommel!
